**Flood Control Project Maintenance
Levee Inspections**
LMA District Cover Sheet
Spring 2014 Levee Inspection Results

San Joaquin County Flood Control and Water Conservation District

Spring 2014 Levee Inspection Results

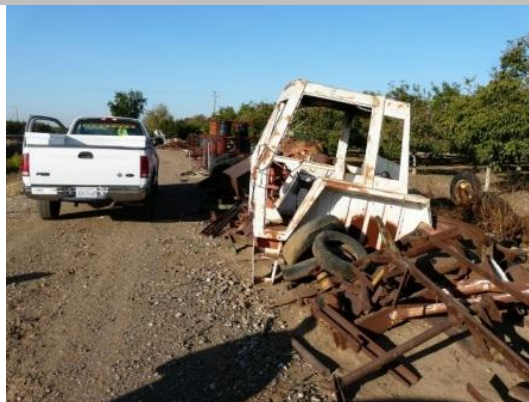
Photo 1 of 1 : pkazi_s_20140415_367.jpg

LM Start	8.68	Rating **	A/W	Issue No.	37
LM End	8.70	Issue Type +	En	Location *	LS
Category	Earthen Levee			GPS Latitude/Longitude	
				Start	End
Item	Encroachments			37.969550 °	37.969391 °
				-121.117927 °	-121.118277 °
DWR ID	DWR_NA0017_15_s _ 2012_37				
Action/Comments					
Equipment

Remove equipment from landside slope of levee at from LM 8.68 to LM 8.70.

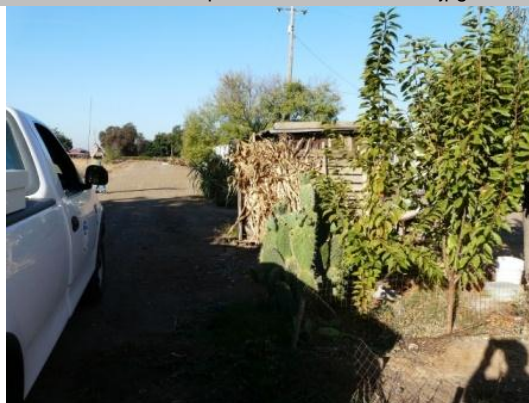
Photo 1 of 1 : pkazi_s_20140415_405.jpg

LM Start	8.72	Rating **	M	Issue No.	83
LM End	8.72	Issue Type +	En	Location *	LS
Category	Earthen Levee			GPS Latitude/Longitude	
				Start	End
Item	Encroachments			37.969305 °	37.969305 °
				-121.118664 °	-121.118664 °
DWR ID	DWR_NA0017_15_s_2012_83				
Action/Comments					
Building

Building, fence and landscaping immediately adjacent to the access road at LM 8.72.

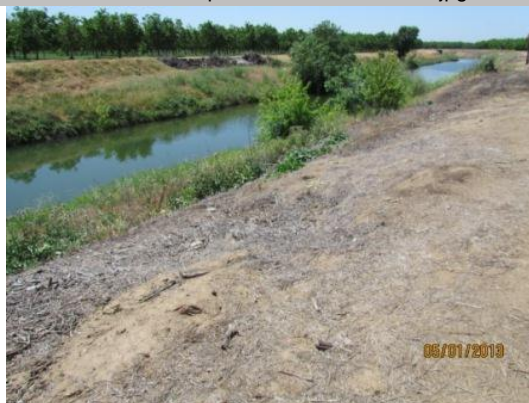
Photo 1 of 1 : pkazi_s_20140415_435.jpg

A slope instability was found on the waterside slope of the levee looking downstream.

LM Start	9.59	Rating **	M	Issue No.	121
LM End	9.59	Issue Type +	Ma	Location *	WS
Category	Earthen Levee			GPS Latitude/Longitude	
				Start	End
Item	Slope Stability			37.967155 °	37.967155 °
				-121.133277 °	-121.133277 °
DWR ID	DWR_NA0017_15_f_2012_121				
Action/Comments					
Repair slope instability.

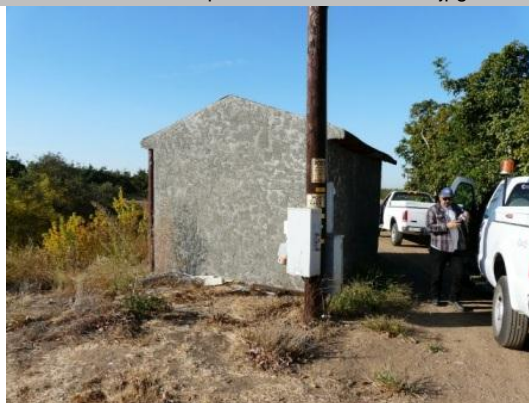
Photo 1 of 2 : pkazi_s_20140415_368.jpg

LM Start	9.63	Rating **	U	Issue No.	40
LM End	9.63	Issue Type +	En	Location *	WS
Category	Earthen Levee			GPS Latitude/Longitude	
				Start	End
Item	Encroachments			37.967017 °	37.967017 °
				-121.133863 °	-121.133863 °
DWR ID	DWR_NA0017_15_s _ 2012_40				
Action/Comments					
Building

Building located at LM 9.63 on waterside of access road. This building appears to be recently constructed and does not currently contain anything.

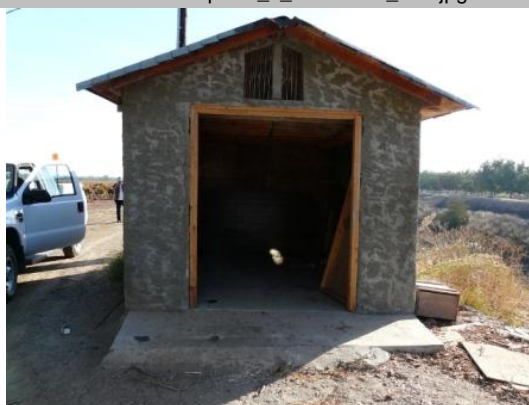
Photo 2 of 2 : pkazi_s_20140415_369.jpg

Additional view of building at LM 9.63.

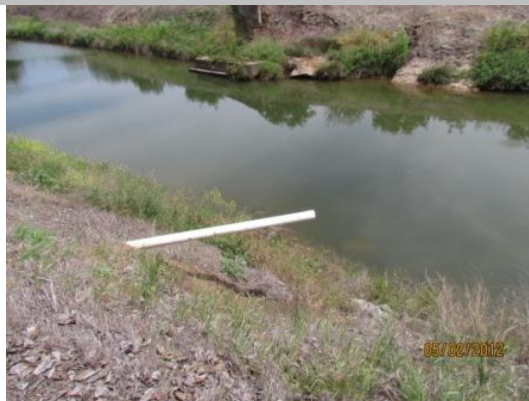
Photo 1 of 1 : pkazi_s_20140415_438.jpg

LM Start	9.76	Rating **	U	Issue No.	136
LM End	9.76	Issue Type +	En	Location *	WS
Category	Earthen Levee			GPS Latitude/Longitude	
				Start	End
Item	Encroachments			37.966230 °	37.966230 °
				-121.136215 °	-121.136215 °
DWR ID	DWR_NA0017_15_s _ 2012_136				
Action/Comments					
Pipe

A perforated PVC pipe was found on the waterside slope of the levee looking upstream.

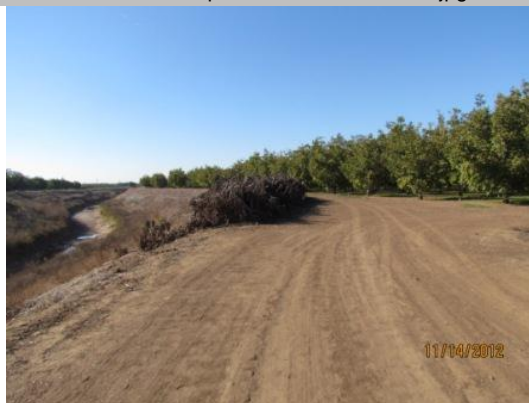
Photo 1 of 1 : pkazi_s_20140415_442.jpg

LM Start	10.01	Rating **	M	Issue No.	147
LM End	10.01	Issue Type +	Ma	Location *	WS
Category	Earthen Levee			GPS Latitude/Longitude	
				Start	End
Item	Encroachments			37.965314 °	37.965314 °
				-121.140296 °	-121.140296 °
DWR ID	DWR_NA0017_15_s_2012_147				
Action/Comments					
Prunings

Prunings were found on the waterside shoulder of the levee looking downstream.

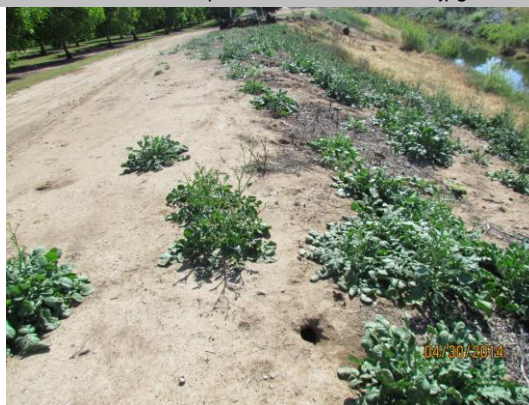
Photo 1 of 1 : pkazi_s_20140505_946.jpg

View of rodent holes on the waterside of the levee looking upstream.

LM Start	10.04	Rating **	M	Issue No.	126
LM End	10.04	Issue Type +	Ma	Location *	WS
Category	Earthen Levee			GPS Latitude/Longitude	
				Start	End
Item	Animal Control			37.965343 °	37.965343 °
				-121.140761 °	-121.140761 °
DWR ID	DWR_NA0017_15_s_2014_126				
Action/Comments					
No rodents visible, but rodent burrows visible; need to backfill and compact or grout burrows.

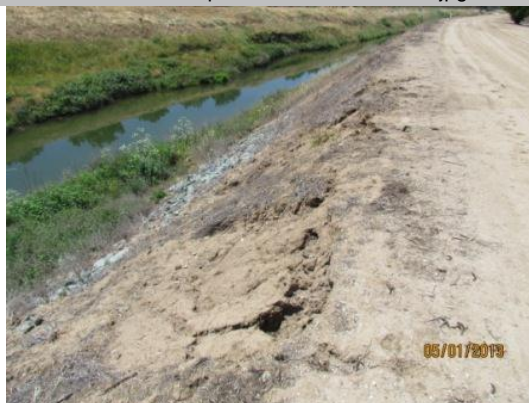
Photo 1 of 1 : pkazi_s_20140415_394.jpg

Slope instability was found on the waterside slope of the levee looking downstream.

LM Start	10.11	Rating **	M	Issue No.	68
LM End	10.11	Issue Type +	Ma	Location *	WS
Category	Earthen Levee			GPS Latitude/Longitude	
				Start	End
Item	Slope Stability			37.965165 °	37.965165 °
				-121.141928 °	-121.141928 °
DWR ID	DWR_NA0017_15_s_2013_68				
Action/Comments					
Repair slope instability.

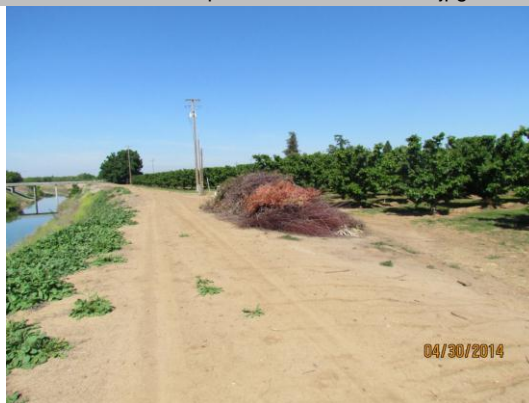
Photo 1 of 1 : pkazi_s_20140505_947.jpg

LM Start	10.35	Rating **	M	Issue No.	87
LM End	10.35	Issue Type +	Ma	Location *	CR
Category	Earthen Levee			GPS Latitude/Longitude	
				Start	End
Item	Encroachments			37.965055 °	37.965055 °
				-121.146293 °	-121.146293 °
DWR ID	DWR_NA0017_15_s_2012_87				
Action/Comments					
Prunings Inspector Comments: Burn pile has been burned but new material has been placed.

Prunings were found on the crown of the levee looking downstream.

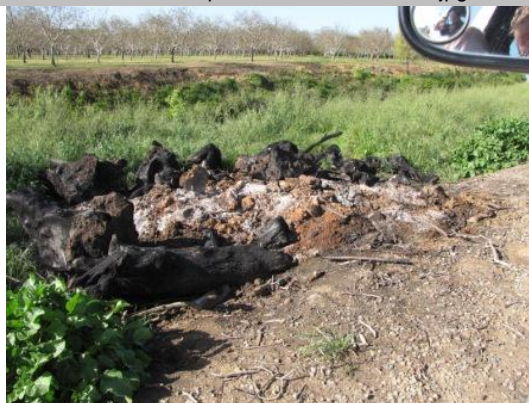
Photo 1 of 2 : pkazi_s_20140415_402.jpg

LM Start	10.62	Rating **	M	Issue No.	78
LM End	10.62	Issue Type +	Ma	Location *	WS
Category	Earthen Levee			GPS Latitude/Longitude	
				Start	End
Item	Encroachments			37.964942 °	37.964942 °
				-121.151073 °	-121.151073 °
DWR ID	DWR_NA0017_15_s_2012_78				
Action/Comments					
Prunings

View of the prunings pile on the waterward slope looking downstream.

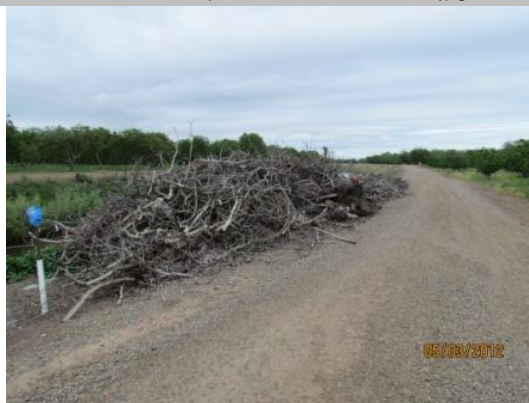
Photo 2 of 2 : pkazi_s_20140415_403.jpg

Prunings were found on the waterside of the levee looking downstream.

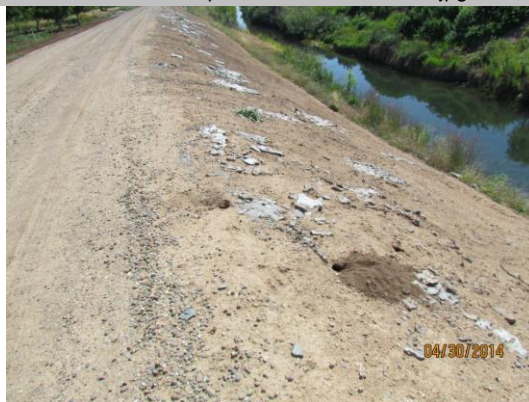
Photo 1 of 2 : pkazi_s_20140505_948.jpg

Updated picture of the rodent holes on the waterside of the levee looking upstream.

LM Start	11.05	Rating **	M	Issue No.	145
LM End	11.05	Issue Type +	Ma	Location *	WS
Category	Earthen Levee			GPS Latitude/Longitude	
				Start	End
Item	Animal Control			37.962984 °	37.962984 °
				-121.158332 °	-121.158332 °
DWR ID	DWR_NA0017_15_f_2012_145				
Action/Comments					
No rodents visible, but rodent burrows visible; need to backfill and compact or grout burrows.

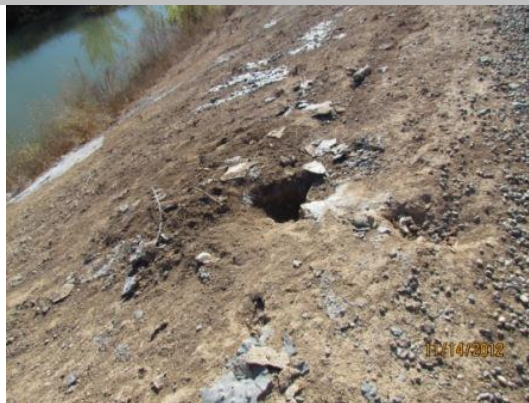
Photo 2 of 2 : pkazi_s_20140415_441.jpg

An animal hole was found on the waterside slope of the levee looking downstream.

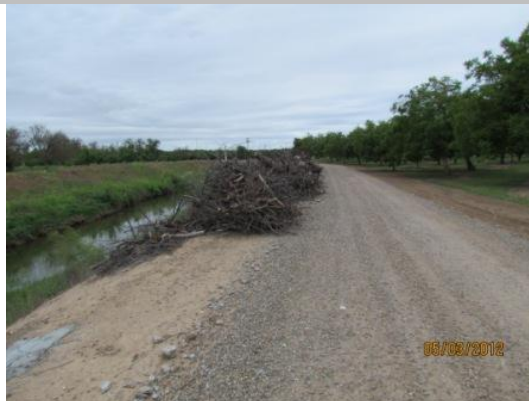
Photo 1 of 1 : pkazi_s_20140415_439.jpg

LM Start	11.06	Rating **	M	Issue No.	137
LM End	11.06	Issue Type +	En	Location *	WS
Category	Earthen Levee			GPS Latitude/Longitude	
				Start	End
Item	Encroachments			37.962885 °	37.962885 °
				-121.158509 °	-121.158509 °
DWR ID	DWR_NA0017_15_s_2012_137				
Action/Comments					
Prunings

Prunings were found on the waterside of the levee looking downstream.

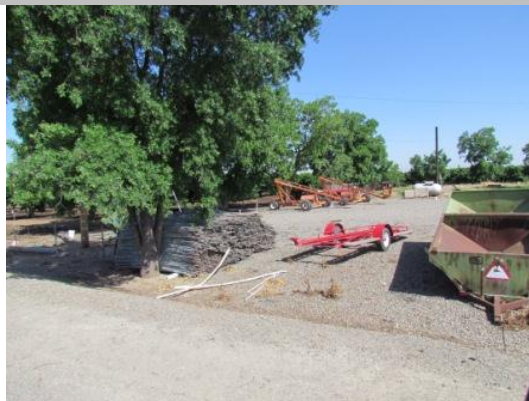
Photo 1 of 1 : pkazi_s_20140415_443.jpg

LM Start	11.58	Rating **	M	Issue No.	150
LM End	11.58	Issue Type +	En	Location *	LS
Category	Earthen Levee			GPS Latitude/Longitude	
				Start	End
Item	Encroachments			37.960824 °	37.960824 °
				-121.166996 °	-121.166996 °
DWR ID	DWR_NA0017_15_s_2012_150				
Action/Comments					
Equipment

Equipment on the landside of the levee. The picture was taken from the crown looking downstream.

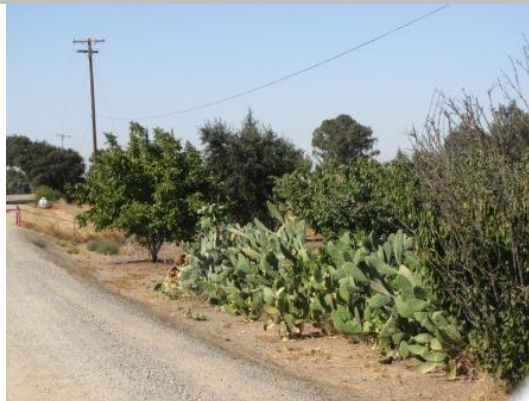
Photo 1 of 1 : pkazi_s_20140415_425.jpg

LM Start	11.61	Rating **	M	Issue No.	109
LM End	11.61	Issue Type +	En	Location *	LS
Category	Earthen Levee			GPS Latitude/Longitude	
				Start	End
Item	Vegetation			37.960762 °	37.960762 °
				-121.167528 °	-121.167528 °
DWR ID	DWR_NA0017_15_s_2012_109				
Action/Comments					
Landscaping

View of cactus within 10 feet of the landward toe blocking visibility and access.

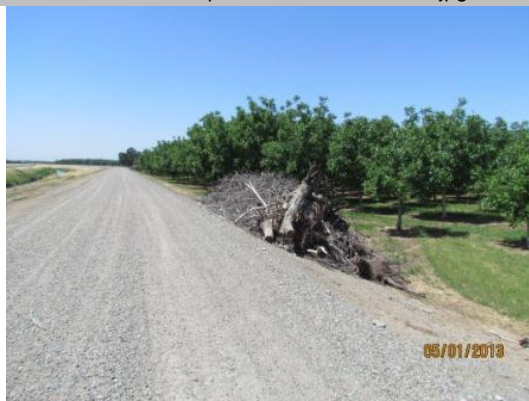
Photo 1 of 1 : pkazi_s_20140415_454.jpg

LM Start	12.08	Rating **	M	Issue No.	989
LM End	12.08	Issue Type +	Ma	Location *	LS
Category	Earthen Levee			GPS Latitude/Longitude	
				Start	End
Item	Encroachments			37.961901 °	37.961901 °
				-121.175973 °	-121.175973 °
DWR ID	DWR_NA0017_15_s_2012_989				
Action/Comments					
Prunings Inspector Comments: Burn pile has been burned but new material has been placed.

Prunings were found on the landside slope of the levee looking downstream.

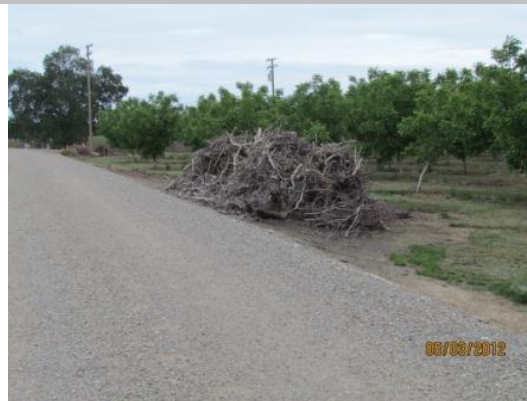
Photo 1 of 1 : pkazi_s_20140415_377.jpg

LM Start	12.21	Rating **	M	Issue No.	45
LM End	12.21	Issue Type +	En	Location *	LS
Category	Earthen Levee			GPS Latitude/Longitude	
				Start	End
Item	Encroachments			37.961945 °	37.961945 °
				-121.178268 °	-121.178268 °
DWR ID	DWR_NA0017_15_s_2012_45				
Action/Comments					
Prunings					
Inspector Comments: Burn pile has been burned but new material has been placed.

Prunings were found on the landside of the levee looking downstream.

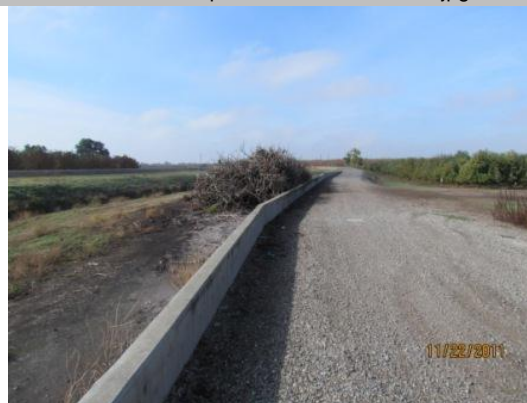
Photo 1 of 1 : pkazi_s_20140415_378.jpg

LM Start	12.82	Rating **	M	Issue No.	46
LM End	12.82	Issue Type +	Ma	Location *	WS
Category	Earthen Levee			GPS Latitude/Longitude	
				Start	End
Item	Encroachments			37.961012 °	37.961012 °
				-121.189067 °	-121.189067 °
DWR ID	DWR_NA0017_15_s_2012_46				
Action/Comments					
Prunings Inspector Comments: Burn pile has been burned but new material has been placed.

Prunings were found on the waterside of the levee looking downstream.

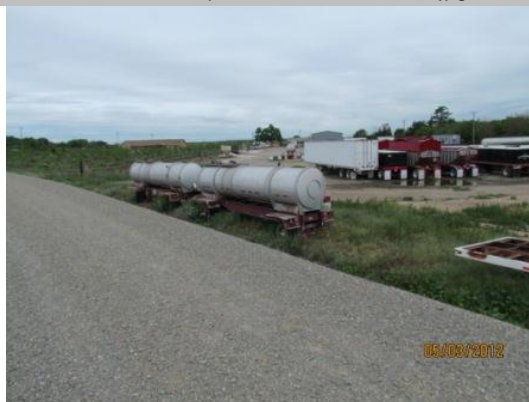
Photo 1 of 1 : pkazi_s_20140415_429.jpg

LM Start	13.25	Rating **	M	Issue No.	114
LM End	13.25	Issue Type +	En	Location *	LS
Category	Earthen Levee			GPS Latitude/Longitude	
				Start	End
Item	Encroachments			37.961002 °	37.961002 °
				-121.196155 °	-121.196155 °
DWR ID	DWR_NA0017_15_s_2012_114				
Action/Comments					
Equipment

Equipment was found on the landside toe of the levee looking downstream.

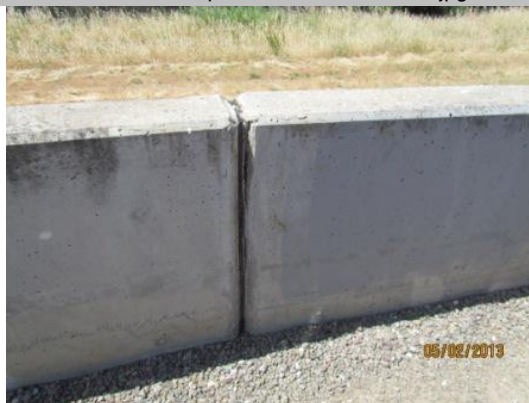
Photo 1 of 1 : pkazi_s_20140415_404.jpg

LM Start	16.08	Rating **	M	Issue No.	80
LM End	16.08	Issue Type +	Ma	Location *	WS
Category	Concrete Floodwalls			GPS Latitude/Longitude	
				Start	End
Item	Monolith Joints			37.978396 °	37.978396 °
				-121.240769 °	-121.240769 °
DWR ID	DWR_NA0017_15_s_2013_80				
Action/Comments

The monolith joint material is deteriorating at the waterside shoulder of the levee looking downstream.

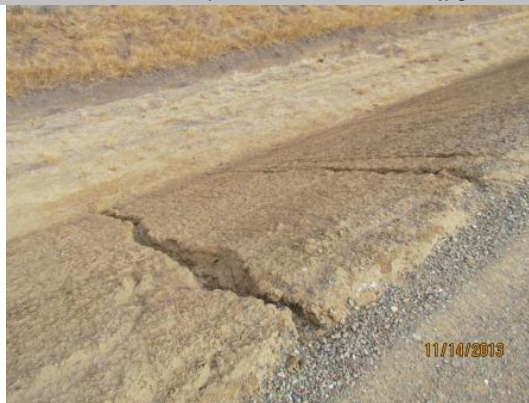
Photo 1 of 1 : pkazi_s_20140415_408.jpg

Erosion caused by runoff on the landside slope of the levee looking upstream.

LM Start	16.39	Rating **	M	Issue No.	88
LM End	16.39	Issue Type +	Ma	Location *	LS
Category	Earthen Levee			GPS Latitude/Longitude	
				Start	End
Item	Erosion / Bank Caving			37.980513 °	37.980513 °
				-121.245495 °	-121.245495 °
DWR ID	DWR_NA0017_15_f_2013_88				
Action/Comments					
Schedule repair of erosion site prior to the next inspection. Inspector Comments: Runoff on the landside of the levee.

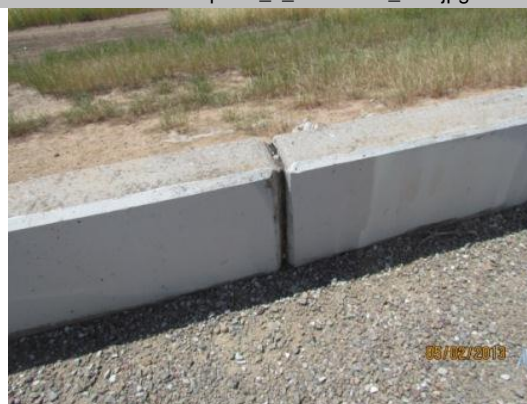
Photo 1 of 1 : pkazi_s_20140415_412.jpg

LM Start	16.87	Rating **	M	Issue No.	93
LM End	16.87	Issue Type +	Ma	Location *	WS
Category	Concrete Floodwalls			GPS Latitude/Longitude	
				Start	End
Item	Monolith Joints			37.983744 °	37.983744 °
				-121.253211 °	-121.253211 °
DWR ID	DWR_NA0017_15_s_2013_93				
Action/Comments

The monolith joint material is deteriorating at the waterside shoulder of the levee looking downstream.

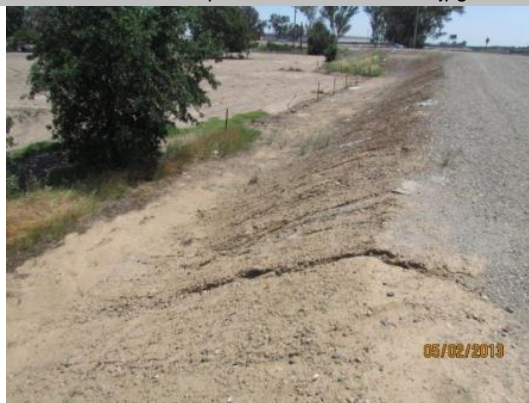
Photo 1 of 1 : pkazi_s_20140415_409.jpg

Slope Instability was found on the landside slope of the levee looking upstream.

LM Start	16.87	Rating **	M	Issue No.	89
LM End	16.87	Issue Type +	Ma	Location *	LS
Category	Earthen Levee			GPS Latitude/Longitude	
				Start	End
Item	Erosion / Bank Caving			37.983744 °	37.983744 °
				-121.253210 °	-121.253210 °
DWR ID	DWR_NA0017_15_s_2013_89				
Action/Comments					
Note and monitor erosion site.					
Inspector Comments: Run off at the landside slope of the levee.

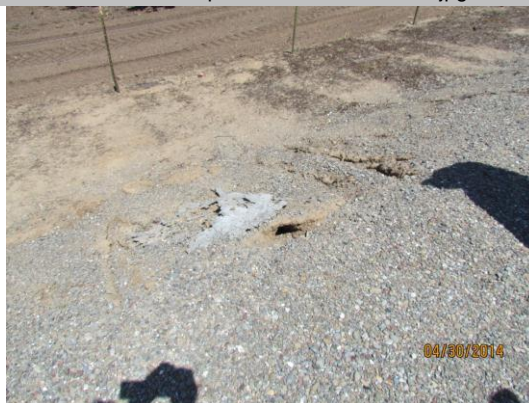
Photo 1 of 1 : pkazi_s_20140505_950.jpg

LM Start	18.39	Rating **	M	Issue No.	129
LM End	18.39	Issue Type +	Ma	Location *	LS
Category	Earthen Levee			GPS Latitude/Longitude	
				Start	End
Item	Animal Control			37.993847 °	37.993847 °
				-121.277254 °	-121.277254 °
DWR ID	DWR_NA0017_15_s_2014_129				
Action/Comments					
No rodents visible, but rodent burrows visible; need to backfill and compact or grout burrows.

An animal hole was found on the landside of the levee looking upstream.

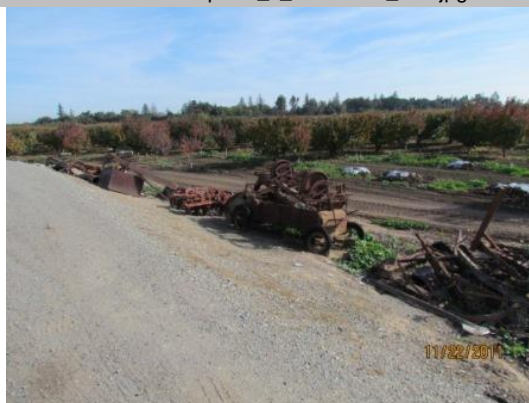
Photo 1 of 1 : pkazi_s_20140415_451.jpg

LM Start	18.44	Rating **	M	Issue No.	567
LM End	18.44	Issue Type +	Ma	Location *	LS
Category	Earthen Levee			GPS Latitude/Longitude	
				Start	End
Item	Encroachments			37.994859 °	37.994859 °
				-121.275862 °	-121.275862 °
DWR ID	DWR_NA0017_15_s_2012_567				
Action/Comments					
Equipment

Equipment was found on the landside of the levee looking downstream.

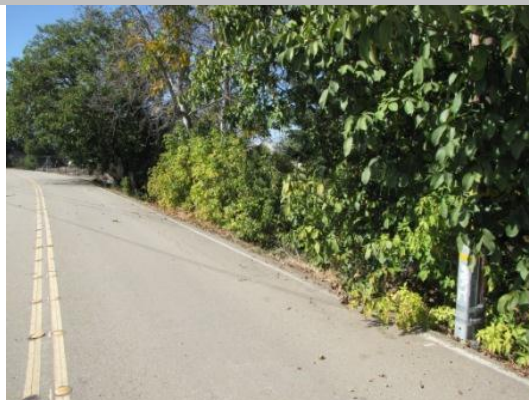
Photo 1 of 1 : pkazi_s_20140415_462.jpg

LM Start	18.54	Rating **	M	Issue No.	1052
LM End	18.55	Issue Type +	En	Location *	LS
Category	Earthen Levee			GPS Latitude/Longitude	
				Start	End
Item	Vegetation			37.995287 °	37.995215 °
				-121.277404 °	-121.277843 °
DWR ID	DWR_NA0017_15_s_2012_1052				
Action/Comments					
Landscaping

View of landowner planted and maintained vegetation along the landward slope looking downstream.

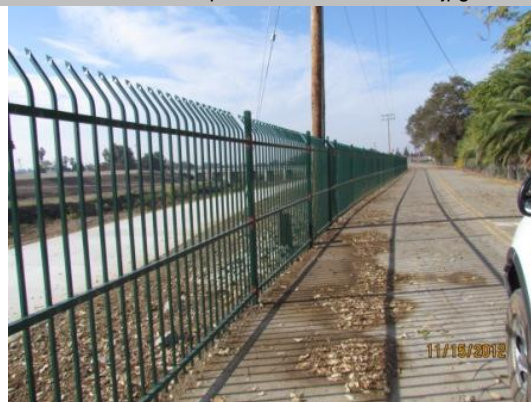
Photo 1 of 1 : pkazi_s_20140415_424.jpg

LM Start	19.80	Rating **	U	Issue No.	107
LM End	19.92	Issue Type +	En	Location *	WS
Category	Earthen Levee			GPS Latitude/Longitude	
				Start	End
Item	Encroachments			37.994671 °	37.994696 °
				-121.279658 °	-121.281905 °
DWR ID	DWR_NA0017_15_f _ 2012_107				
Action/Comments					
Fence					
Inspector Comments: City of Stockton placed this fence on the waterside shoulder of the levee.

A fence was placed by the City of Stockton on the waterside shoulder of the levee looking downstream.

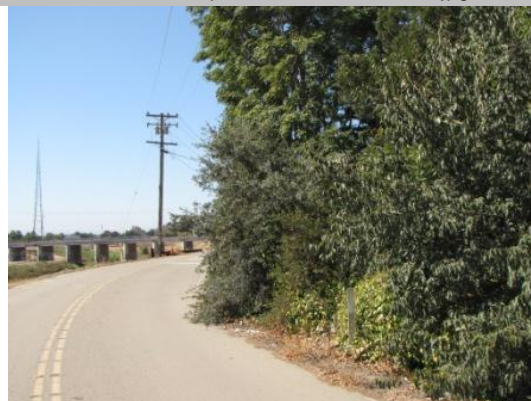
Photo 1 of 1 : pkazi_s_20140415_463.jpg

LM Start	19.80	Rating **	M	Issue No.	1054
LM End	19.86	Issue Type +	En	Location *	LS
Category	Earthen Levee			GPS Latitude/Longitude	
				Start	End
Item	Vegetation			37.994756 °	37.994729 °
				-121.279161 °	-121.280718 °
DWR ID	DWR_NA0017_15_s _ 2012_1054				
Action/Comments					
Landscaping

View of landowner planted and maintained vegetation along the landward slope looking downstream.

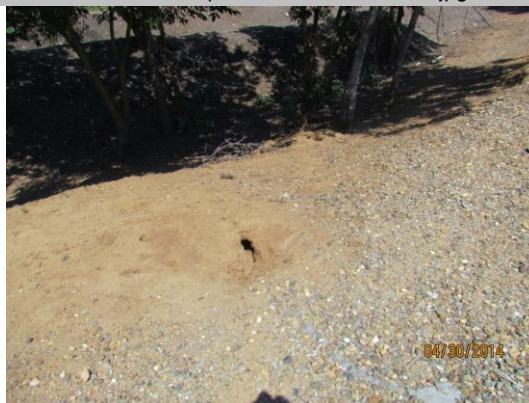
Photo 1 of 1 : pkazi_s_20140505_951.jpg

LM Start	20.09	Rating **	M	Issue No.	132
LM End	20.09	Issue Type +	Ma	Location *	LS
Category	Earthen Levee			GPS Latitude/Longitude	
				Start	End
Item	Animal Control			37.993719 °	37.993719 °
				-121.284698 °	-121.284698 °
DWR ID	DWR_NA0017_15_s_2014_132				
Action/Comments					
No rodents visible, but rodent burrows visible; need to backfill and compact or grout burrows.

A rodent hole was found on the landside of the levee looking from the crown.

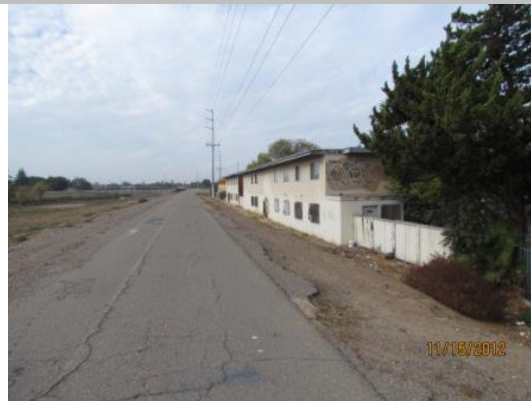
Photo 1 of 1 : pkazi_s_20140415_381.jpg

LM Start	20.91	Rating **	U	Issue No.	53
LM End	21.01	Issue Type +	En	Location *	LS
Category	Earthen Levee			GPS Latitude/Longitude	
				Start	End
Item	Encroachments			37.992015 °	37.992103 °
				-121.298692 °	-121.300505 °
DWR ID	DWR_NA0017_15_s_2012_53				
Action/Comments					
Building

View of the buildings on the landside of the levee looking downstream.

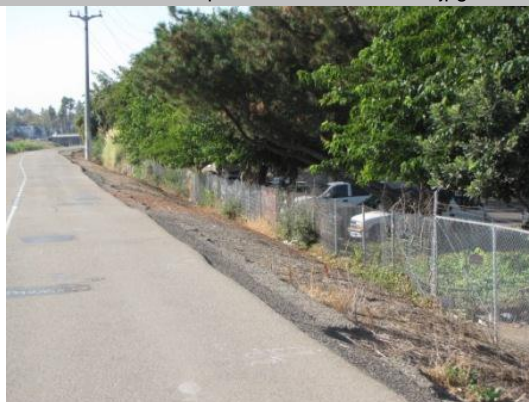
Photo 1 of 1 : pkazi_s_20140415_464.jpg

LM Start	21.46	Rating **	M	Issue No.	1062
LM End	21.61	Issue Type +	En	Location *	LS
Category	Earthen Levee			GPS Latitude/Longitude	
				Start	End
Item	Encroachments			37.988543 °	37.986783 °
				-121.307211 °	-121.308158 °
DWR ID	DWR_NA0017_15_s_2012_1062				
Action/Comments					
Fence

View of fence along the landward toe looking downstream.

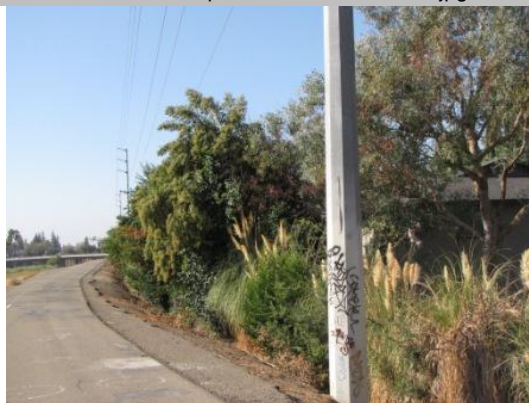
Photo 1 of 1 : pkazi_s_20140415_383.jpg

LM Start	21.52	Rating **	M	Issue No.	56
LM End	21.73	Issue Type +	En	Location *	LS
Category	Earthen Levee			GPS Latitude/Longitude	
				Start	End
Item	Vegetation			37.987718 °	37.985250 °
				-121.307630 °	-121.309249 °
DWR ID	DWR_NA0017_15_s_2012_56				
Action/Comments					
Landscaping

View of landscaping along the landward slope and toe looking downstream.

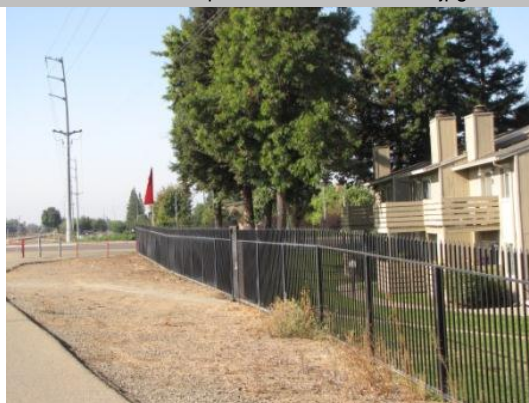
Photo 1 of 1 : pkazi_s_20140415_465.jpg

LM Start	21.73	Rating **	M	Issue No.	1063
LM End	21.77	Issue Type +	En	Location *	LS
Category	Earthen Levee			GPS Latitude/Longitude	
				Start	End
Item	Encroachments			37.985238 °	37.984896 °
				-121.309264 °	-121.309735 °
DWR ID	DWR_NA0017_15_s_2012_1063				
Action/Comments					
Fence

View of fence along the landward shoulder looking downstream.

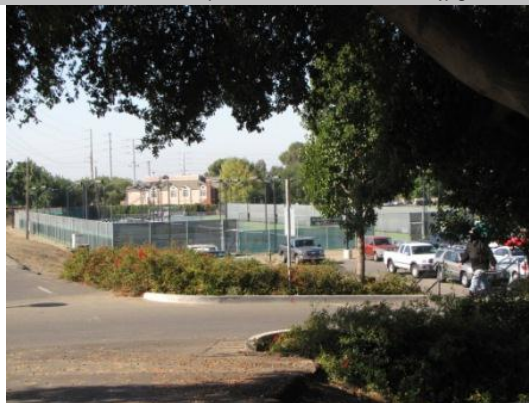
Photo 1 of 1 : pkazi_s_20140415_466.jpg

LM Start	22.11	Rating **	M	Issue No.	1065
LM End	22.11	Issue Type +	En	Location *	LS
Category	Earthen Levee			GPS Latitude/Longitude	
				Start	End
Item	Vegetation			37.981675 °	37.981675 °
				-121.314329 °	-121.314329 °
DWR ID	DWR_NA0017_15_s_2012_1065				
Action/Comments					
Landscaping

View of landscaping maintained by UOP along the landward slope looking downstream.

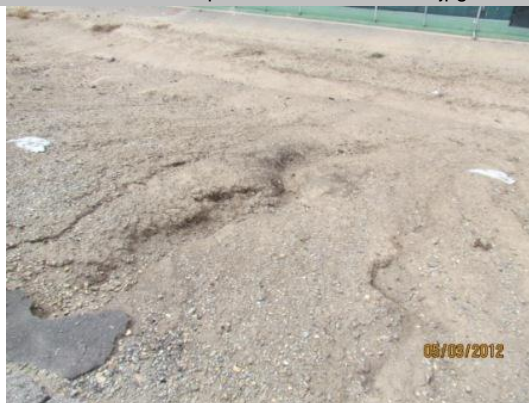
Photo 1 of 3 : pkazi_s_20140415_445.jpg

LM Start	22.17	Rating **	M	Issue No.	173
LM End	22.17	Issue Type +	Ma	Location *	LS
Category	Earthen Levee			GPS Latitude/Longitude	
				Start	End
Item	Erosion / Bank Caving			37.981068 °	37.981068 °
				-121.315159 °	-121.315159 °
DWR ID	DWR_NA0017_15_s_2012_173				
Action/Comments					
Schedule repair of erosion site prior to the next inspection.

Erosion was found due to runoff on the landside of the levee looking downstream.

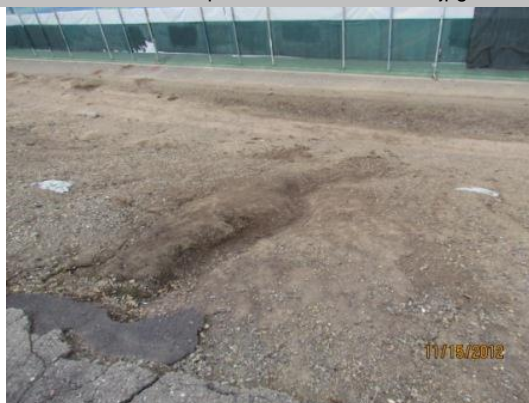
Photo 2 of 3 : pkazi_s_20140415_446.jpg

LM Start	22.17	Rating **	M	Issue No.	173 (cont)
LM End	22.17	Issue Type +	Ma	Location *	LS

Updated picture of the erosion located on the landside of the levee looking downstream.

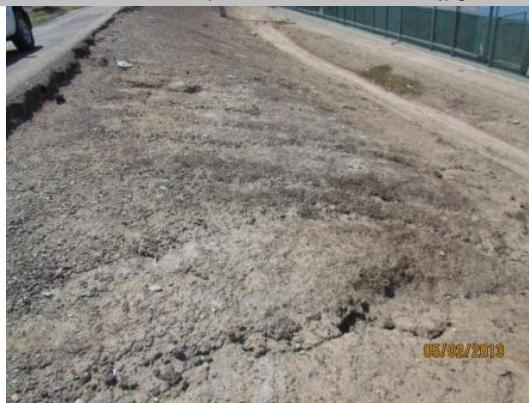
Photo 3 of 3 : pkazi_s_20140415_447.jpg

LM Start	22.17	Rating **	M	Issue No.	173 (cont)
LM End	22.17	Issue Type +	Ma	Location *	LS

Updated picture of the erosion caused by run off on the landside slope of the levee looking downstream during spring 2013 inspection.

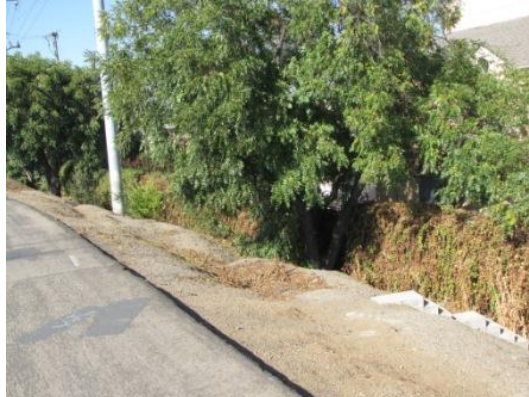
Photo 1 of 1 : pkazi_s_20140415_384.jpg

LM Start	22.27	Rating **	M	Issue No.	57
LM End	22.32	Issue Type +	En	Location *	LS
Category	Earthen Levee			GPS Latitude/Longitude	
				Start	End
Item	Vegetation			37.980533 °	37.980285 °
				-121.316473 °	-121.317410 °
DWR ID	DWR_NA0017_15_s_2012_57				
Action/Comments					
Landscaping

View of landscaping along the landward toe of the levee looking downstream.

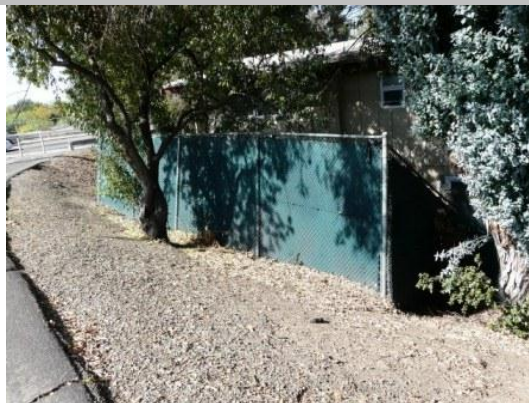
Photo 1 of 1 : pkazi_s_20140415_414.jpg

LM Start	22.36	Rating **	M	Issue No.	95
LM End	22.37	Issue Type +	En	Location *	LS
Category	Earthen Levee			GPS Latitude/Longitude	
				Start	End
Item	Encroachments			37.979996 °	37.979969 °
				-121.318045 °	-121.318236 °
DWR ID	DWR_NA0017_15_s_2012_95				
Action/Comments					
Fence

Fence located from LM 22.36 to LM 22.37 significantly encroaches onto landside levee slope.

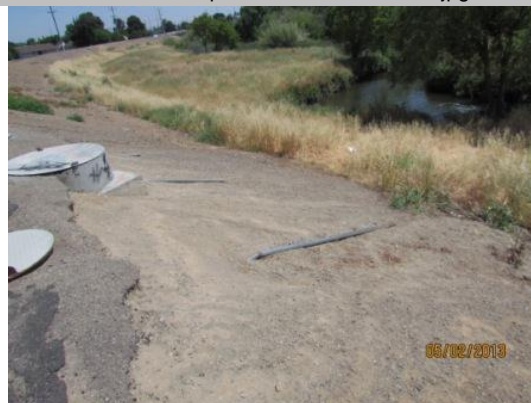
Photo 1 of 1 : pkazi_s_20140415_432.jpg

LM Start	22.59	Rating **	M	Issue No.	118
LM End	22.59	Issue Type +	En	Location *	WS
Category	Earthen Levee			GPS Latitude/Longitude	
				Start	End
Item	Encroachments			37.981443 °	37.981443 °
				-121.321931 °	-121.321931 °
DWR ID	DWR_NA0017_15_s_2013_118				
Action/Comments					
Pipe Inspector Comments: Exposed pipe causing erosion on the waterside slope of the levee.

View of the exposed pipe causing erosion on the waterside slope of the levee looking upstream.

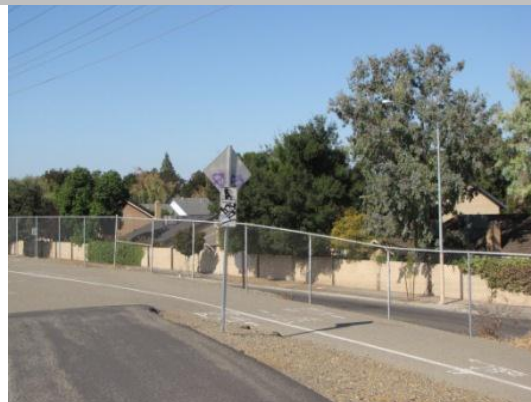
Photo 1 of 1 : pkazi_s_20140415_467.jpg

LM Start	22.88	Rating **	U	Issue No.	1067
LM End	22.90	Issue Type +	En	Location *	LS
Category	Earthen Levee			GPS Latitude/Longitude	
				Start	End
Item	Encroachments			37.982270 °	37.982210 °
				-121.327070 °	-121.327567 °
DWR ID	DWR_NA0017_15_s_2012_1067				
Action/Comments					
Fence

View of a fence along the landward shoulder looking downstream.

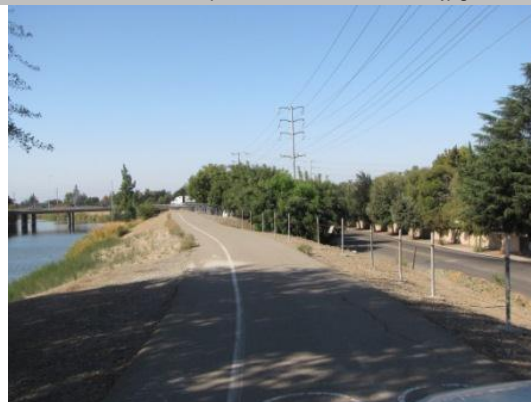
Photo 1 of 1 : pkazi_s_20140415_468.jpg

LM Start	23.54	Rating **	M	Issue No.	1068
LM End	23.69	Issue Type +	En	Location *	LS
Category	Earthen Levee			GPS Latitude/Longitude	
				Start	End
Item	Encroachments			37.980240 °	37.979757 °
				-121.338605 °	-121.341113 °
DWR ID	DWR_NA0017_15_s_2012_1068				
Action/Comments					
Fence					
Inspector Comments: Post & Cable Fence

View of a fence along landward shoulder looking downstream.

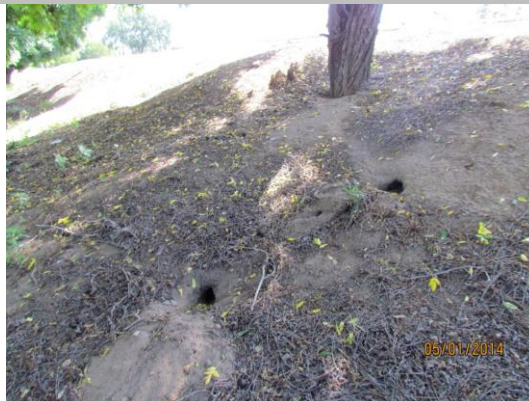
Photo 1 of 2 : pkazi_s_20140505_953.jpg

LM Start	23.61	Rating **	M	Issue No.	119
LM End	23.61	Issue Type +	Ma	Location *	LS
Category	Earthen Levee			GPS Latitude/Longitude	
				Start	End
Item	Animal Control			37.979951 °	37.979951 °
				-121.339787 °	-121.339787 °
DWR ID	DWR_NA0017_15_s_2013_119				
Action/Comments					
No rodents visible, but rodent burrows visible; need to backfill and compact or grout burrows.

Rodent holes were found on the landside of the levee looking upstream.

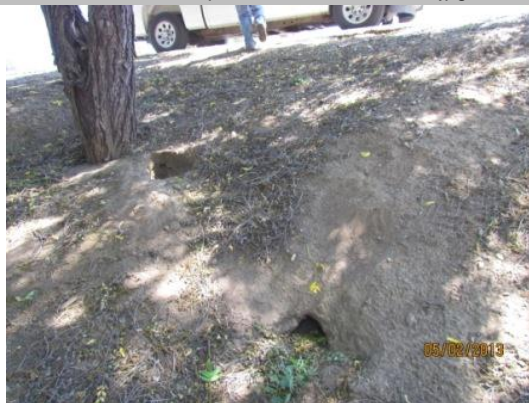
Photo 2 of 2 : pkazi_s_20140415_433.jpg

An animal hole was found on the landside slope of the levee looking upstream.

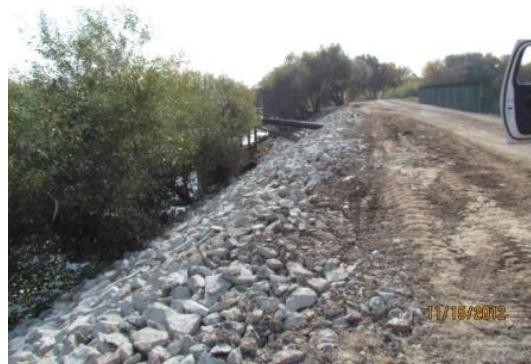
Photo 1 of 1 : pkazi_s_20140415_448.jpg

LM Start	24.18	Rating **	A/W	Issue No.	187
LM End	24.18	Issue Type +	Ob	Location *	WS
Category	Earthen Levee			GPS Latitude/Longitude	
				Start	End
Item	Riprap Revetments			37.974858 °	37.974858 °
				-121.347718 °	-121.347718 °
DWR ID	DWR_NA0017_15_f_2012_187				
Action/Comments

Revetment was placed by the LMA on the waterside slope of the levee looking downstream.

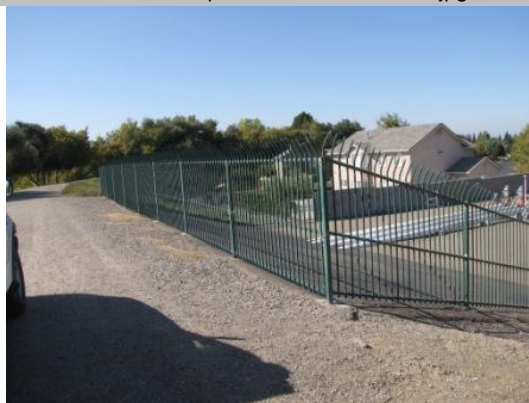
Photo 1 of 1 : pkazi_s_20140415_469.jpg

LM Start	24.20	Rating **	U	Issue No.	1070
LM End	24.21	Issue Type +	En	Location *	LS
Category	Earthen Levee			GPS Latitude/Longitude	
				Start	End
Item	Encroachments			37.974670 °	37.974499 °
				-121.347822 °	-121.347919 °
DWR ID	DWR_NA0017_15_s_2012_1070				
Action/Comments					
Fence

View of fence along the landward shoulder looking downstream.

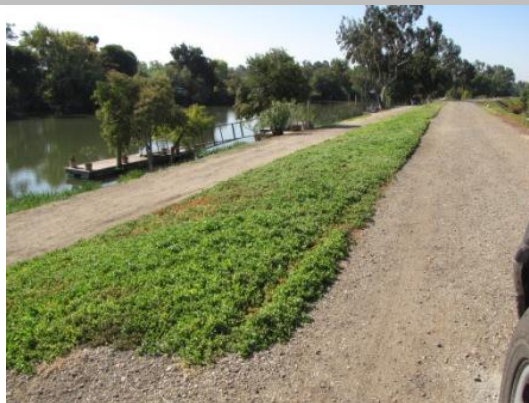
Photo 1 of 1 : pkazi_s_20140415_470.jpg

LM Start	24.65	Rating **	A/W	Issue No.	1071
LM End	25.59	Issue Type +	En	Location *	WS
Category	Earthen Levee			GPS Latitude/Longitude	
				Start	End
Item	Vegetation			37.970707 °	37.967737 °
				-121.353458 °	-121.368923 °
DWR ID	DWR_NA0017_15_s_2012_1071				
Action/Comments					
Landscaping Inspector Comments: Landowner plantings, iceplant, etc. with irrigation systems. All of them have permits.

View of typical landowner planted and maintained landscaping and irrigation along the waterward shoulder and slope looking downstream.

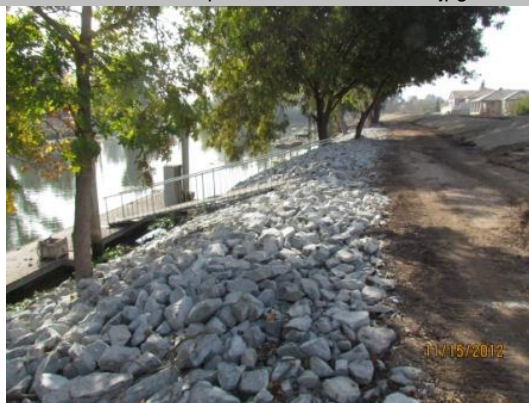
Photo 1 of 1 : pkazi_s_20140415_449.jpg

LM Start	24.84	Rating **	A/W	Issue No.	188
LM End	24.84	Issue Type +	Ob	Location *	WS
Category	Earthen Levee			GPS Latitude/Longitude	
				Start	End
Item	Riprap Revetments			37.969095 °	37.969095 °
				-121.356301 °	-121.356301 °
DWR ID	DWR_NA0017_15_f_2012_188				
Action/Comments

Revetments were placed by the LMA on the waterside slope of the levee looking downstream.

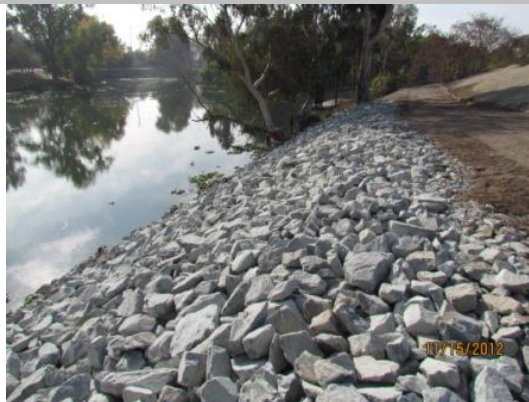
Photo 1 of 1 : pkazi_s_20140415_450.jpg

LM Start	25.00	Rating **	A/W	Issue No.	189
LM End	25.00	Issue Type +	Ob	Location *	WS
Category	Earthen Levee			GPS Latitude/Longitude	
				Start	End
Item	Riprap Revetments			37.967943 °	37.967943 °
				-121.358711 °	-121.358711 °
DWR ID	DWR_NA0017_15_f _ 2012_189				
Action/Comments

Revetments were placed by the LMA on the waterside slope of the levee looking downstream.

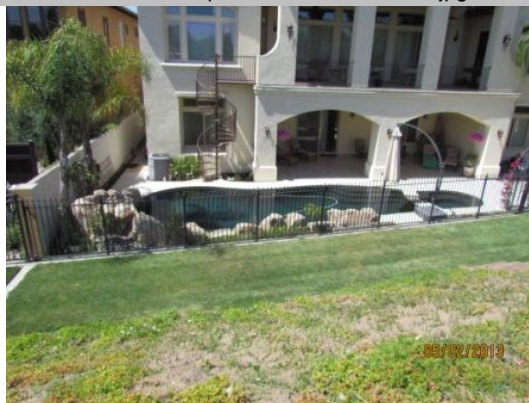
Photo 1 of 1 : pkazi_s_20140415_385.jpg

LM Start	25.35	Rating **	M	Issue No.	58
LM End	25.35	Issue Type +	En	Location *	LS
Category	Earthen Levee			GPS Latitude/Longitude	
				Start	End
Item	Encroachments			37.968056 °	37.968056 °
				-121.364686 °	-121.364686 °
DWR ID	DWR_NA0017_15_s_2013_58				
Action/Comments					
Pool					
Inspector Comments: This pool doesn't have any permit.

A pool was found on the landside toe of the levee looking downstream.

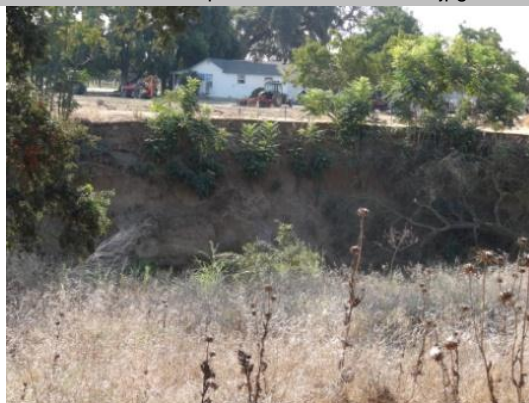
Photo 1 of 1 : pkazi_s_20140415_489.jpg

LM Start	0.13	Rating **	U	Issue No.	41
LM End	0.47	Issue Type +	Ma	Location *	WS
Category	Supplemental			GPS Latitude/Longitude	
				Start	End
Item	DWR Erosion Survey			38.048159 °	38.048159 °
				-121.016427 °	-121.016427 °
DWR ID	DWR_NA0017_16_s_2014_41				
Action/Comments					
Inspector Comments: 09/12/2013: Site has been visited and signs of new erosion are visible. 08/22/2012: The erosion was surveyed and documented for monitoring purpose. There is no levee structure on the site, only high ground protecting the land behind. The levee crest width and levee height were not measured or estimated in the field. [2013 Site ID:NA0017U16RM23.35]

Front view of erosion. Looking from the right side of the river.

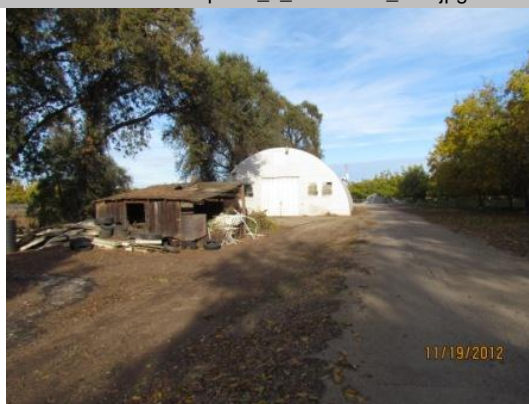
Photo 1 of 1 : pkazi_s_20140415_532.jpg

LM Start	0.54	Rating **	U	Issue No.	99
LM End	0.54	Issue Type +	En	Location *	WS
Category	Earthen Levee			GPS Latitude/Longitude	
				Start	End
Item	Encroachments			38.046569 °	38.046569 °
				-121.020075 °	-121.020075 °
DWR ID	DWR_NA0017_16_s_2012_99				
Action/Comments					
Building

A building was located on the waterside shoulder of the levee looking upstream.

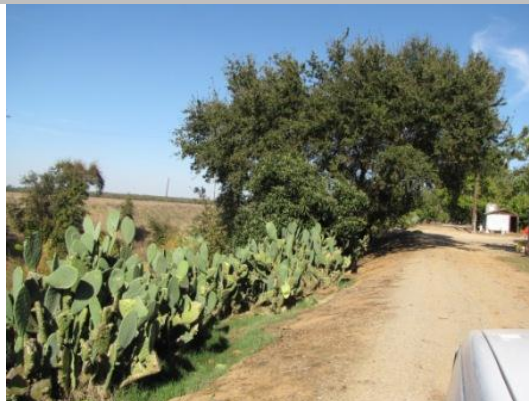
Photo 1 of 1 : pkazi_s_20140415_598.jpg

LM Start	0.83	Rating **	M	Issue No.	179
LM End	0.89	Issue Type +	En	Location *	WS
Category	Earthen Levee			GPS Latitude/Longitude	
				Start	End
Item	Vegetation			38.044312 °	38.043691 °
				-121.024377 °	-121.024946 °
DWR ID	DWR_NA0017_16_s_2012_179				
Action/Comments					
Landscaping

View of landowner maintained landscaping on waterward side looking upstream.

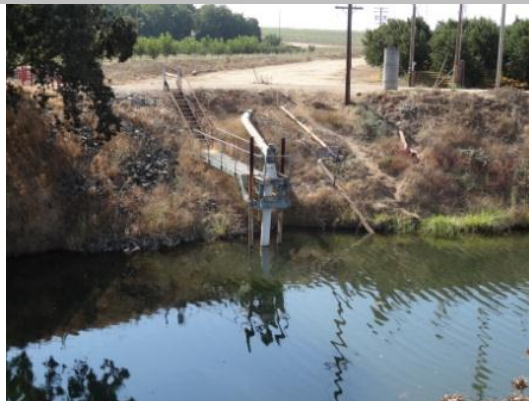
Photo 1 of 1 : pkazi_s_20140415_583.jpg

LM Start	1.13	Rating **	U	Issue No.	163
LM End	1.13	Issue Type +	Ma	Location *	WS
Category	Supplemental			GPS Latitude/Longitude	
				Start	End
Item	DWR Erosion Survey			38.041260 °	38.041260 °
				-121.027730 °	-121.027730 °
DWR ID	DWR_NA0017_16_s_2014_163				
Action/Comments					
Inspector Comments: 9/12/2013: No significant changes observed. 08/22/2012: Erosion is at the outside corner of a river bend, and next to a tree at the levee toe. Irrigation structure presents at the site. There is no levee structure on site. The levee crest width and levee height were not measured or estimated in the field. [2013 Site ID:NA0017U16RM22.58]

Front view of erosion. Note the irrigation pipe at the erosion site.

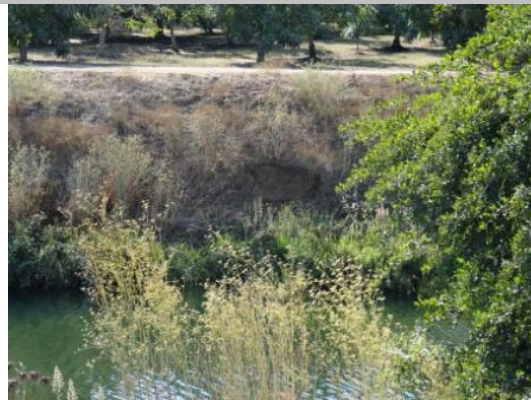
Photo 1 of 1 : pkazi_s_20140415_585.jpg

LM Start	1.74	Rating **	U	Issue No.	165
LM End	1.75	Issue Type +	Ma	Location *	WS
Category	Supplemental			GPS Latitude/Longitude	
				Start	End
Item	DWR Erosion Survey			38.039110 °	38.039110 °
				-121.037840 °	-121.037840 °
DWR ID	DWR_NA0017_16_s _ 2014_165				
Action/Comments					
Inspector Comments: 9/12/2013: No significant changes observed. 08/22/2012: Site is covered with dense vegetation. A scarp erosion is adjacent to a pocket erosion at the downstream. There is no levee structure on site. The levee crest width and levee height were not measured or estimated in the field. [2013 Site ID:NA0017U16RM22.01]

Front view of the pocket erosion.

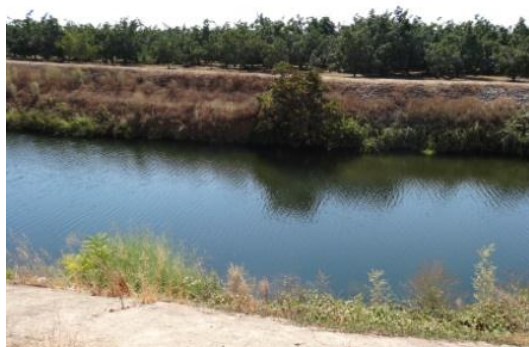
Photo 1 of 1 : pkazi_s_20140415_586.jpg

LM Start	1.75	Rating **	M	Issue No.	166
LM End	1.76	Issue Type +	Ma	Location *	WS
Category	Supplemental			GPS Latitude/Longitude	
				Start	End
Item	DWR Erosion Survey			38.038080 °	38.038080 °
				-121.038676 °	-121.038676 °
DWR ID	DWR_NA0017_16_s _ 2014_166				
Action/Comments					
Inspector Comments: 9/12/2013: No significant changes observed. 08/22/2012: Erosion is covered by dense vegetation. There is no levee structure on site. The levee crest width and levee height were not measured or estimated in the field. [2013 Site ID:NA0017U16RM21.95]

Front view of erosion site.

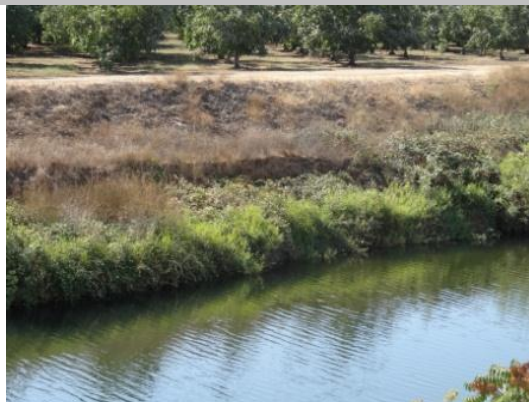
Photo 1 of 1 : pkazi_s_20140415_588.jpg

LM Start	1.77	Rating **	M	Issue No.	168
LM End	1.78	Issue Type +	Ma	Location *	WS
Category	Supplemental			GPS Latitude/Longitude	
				Start	End
Item	DWR Erosion Survey			38.037906 °	38.037906 °
				-121.038949 °	-121.038949 °
DWR ID	DWR_NA0017_16_s _ 2014_168				
Action/Comments					
Inspector Comments: 9/12/2013: No significant changes observed. 08/22/2012: Site is covered by dense vegetation. Berm width is estimated as 5 ft. There is no levee structure on site. The levee crest width and levee height were not measured or estimated in the field. [2013 Site ID:NA0017U16RM21.94]

Looking downstream at the erosion.

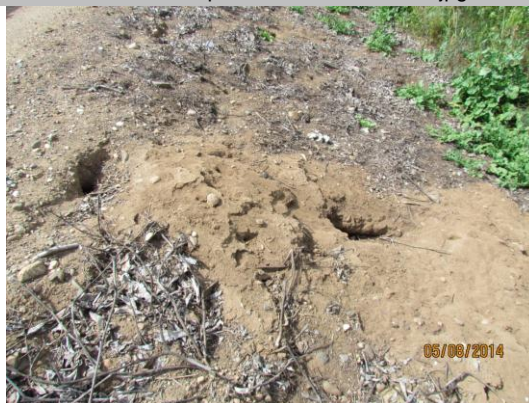
Photo 1 of 1 : pkazi_s_20140512_978.jpg

Rodent holes were found on the waterside of the levee looking downstream.

LM Start	1.88	Rating **	M	Issue No.	183
LM End	1.88	Issue Type +	Ma	Location *	WS
Category	Earthen Levee			GPS Latitude/Longitude	
				Start	End
Item	Animal Control			38.037320 °	38.037320 °
				-121.039563 °	-121.039563 °
DWR ID	DWR_NA0017_16_s_2014_183				
Action/Comments					
No rodents visible, but rodent burrows visible; need to backfill and compact or grout burrows.

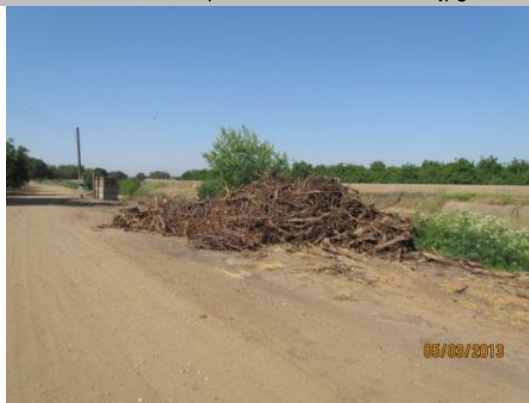
Photo 1 of 1 : pkazi_s_20140415_478.jpg

LM Start	1.95	Rating **	M	Issue No.	13
LM End	1.95	Issue Type +	En	Location *	WS
Category	Earthen Levee			GPS Latitude/Longitude	
				Start	End
Item	Encroachments			38.036468 °	38.036468 °
				-121.040187 °	-121.040187 °
DWR ID	DWR_NA0017_16_s_2013_13				
Action/Comments					
Prunings

Prunings were found on the waterside shoulder of the levee looking downstream.

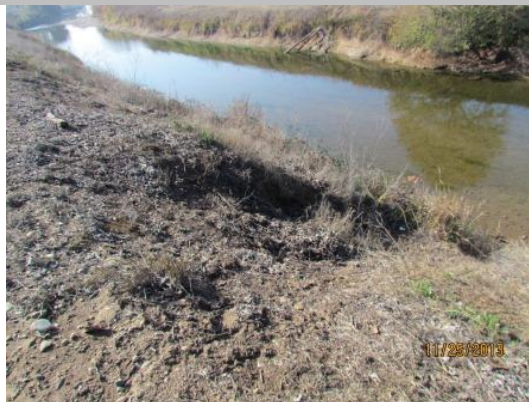
Photo 1 of 1 : pkazi_s_20140415_575.jpg

Erosion was found on the waterside of the levee looking downstream.

LM Start	1.97	Rating **	M	Issue No.	155
LM End	1.97	Issue Type +	Ma	Location *	WS
Category	Earthen Levee			GPS Latitude/Longitude	
				Start	End
Item	Erosion / Bank Caving			38.036248 °	38.036248 °
				-121.040408 °	-121.040408 °
DWR ID	DWR_NA0017_16_f_2013_155				
Action/Comments					
Schedule repair of erosion site prior to the next inspection.

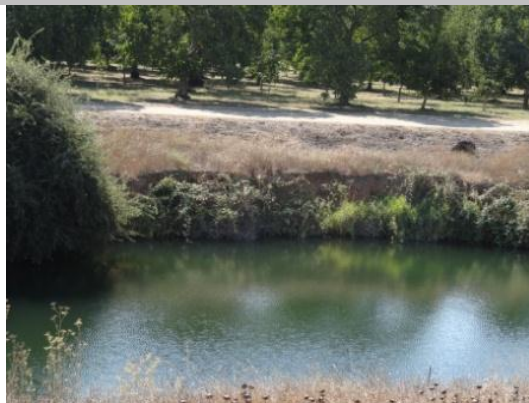
Photo 1 of 1 : pkazi_s_20140415_591.jpg

LM Start	2.31	Rating **	M	Issue No.	171
LM End	2.32	Issue Type +	Ma	Location *	WS
Category	Supplemental			GPS Latitude/Longitude	
				Start	End
Item	DWR Erosion Survey			38.033072 °	38.033072 °
				-121.044970 °	-121.044970 °
DWR ID	DWR_NA0017_16_s_2014_171				
Action/Comments					
Inspector Comments: 9/12/2013: No significant changes observed. 08/22/2012: Site is covered with dense vegetation. There is no levee structure on site. The levee crest width and levee height were not measured or estimated in the field. [2013 Site ID:NA0017U16RM20.71]

Front view of the erosion. Site is covered with vegetation and trees.

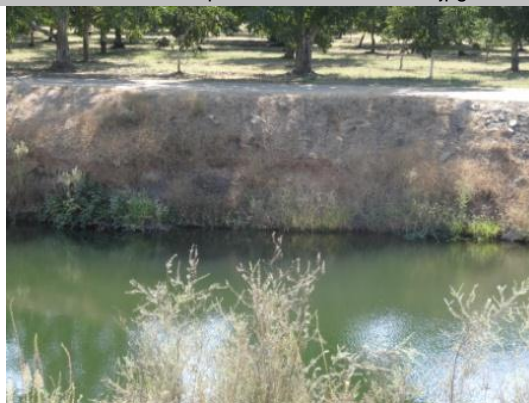
Photo 1 of 1 : pkazi_s_20140415_593.jpg

LM Start	2.37	Rating **	U	Issue No.	173
LM End	2.38	Issue Type +	Ma	Location *	WS
Category	Supplemental			GPS Latitude/Longitude	
				Start	End
Item	DWR Erosion Survey			38.032202 °	38.032202 °
				-121.045226 °	-121.045226 °
DWR ID	DWR_NA0017_16_s_2014_173				
Action/Comments					
Inspector Comments: 9/12/2013: No significant changes observed. 08/22/2012: The erosion was first reported in the 2012 spring levee inspection report. There is no levee structure on site. The levee crest width and levee height were not measured or estimated in the field. [2013 Site ID:NA0017U16RM20.62]

Close view of erosion. Note the vegetation at the site.

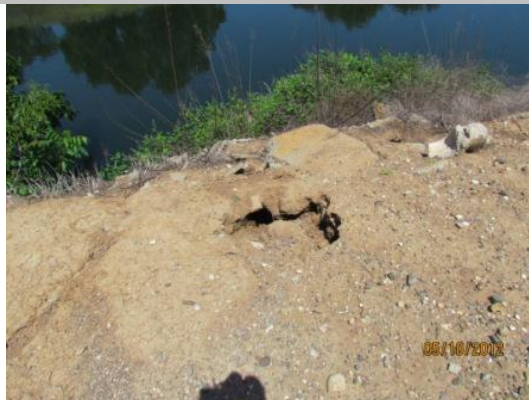
Photo 1 of 2 : pkazi_s_20140415_616.jpg

Slope instability was found on the waterside of the levee looking upstream.

LM Start	2.42	Rating **	M	Issue No.	213
LM End	2.42	Issue Type +	Ma	Location *	WS
Category	Earthen Levee			GPS Latitude/Longitude	
				Start	End
Item	Slope Stability			38.031763 °	38.031763 °
				-121.045808 °	-121.045808 °
DWR ID	DWR_NA0017_16_f_2012_213				
Action/Comments					
Repair slope instability.

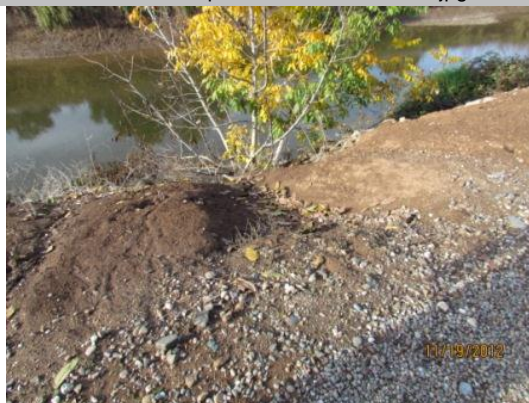
Photo 2 of 2 : pkazi_s_20140415_617.jpg

Updated picture of the slope instability on the waterside shoulder of the levee looking upstream.

LM Start	2.42	Rating **	M	Issue No.	213 (cont)	
LM End	2.42	Issue Type +	Ma	Location *	WS	
Category	Earthen Levee			GPS Latitude/Longitude		
				Start		End
Item	Slope Stability			38.031763 °		38.031763 °
				-121.045808 °		-121.045808 °
DWR ID	DWR_NA0017_16_f_2012_213					
Action/Comments						
Repair slope instability.
